Black Mesa Project Lowers Flooding Risk in Albuquerque's South Valley

May 2020

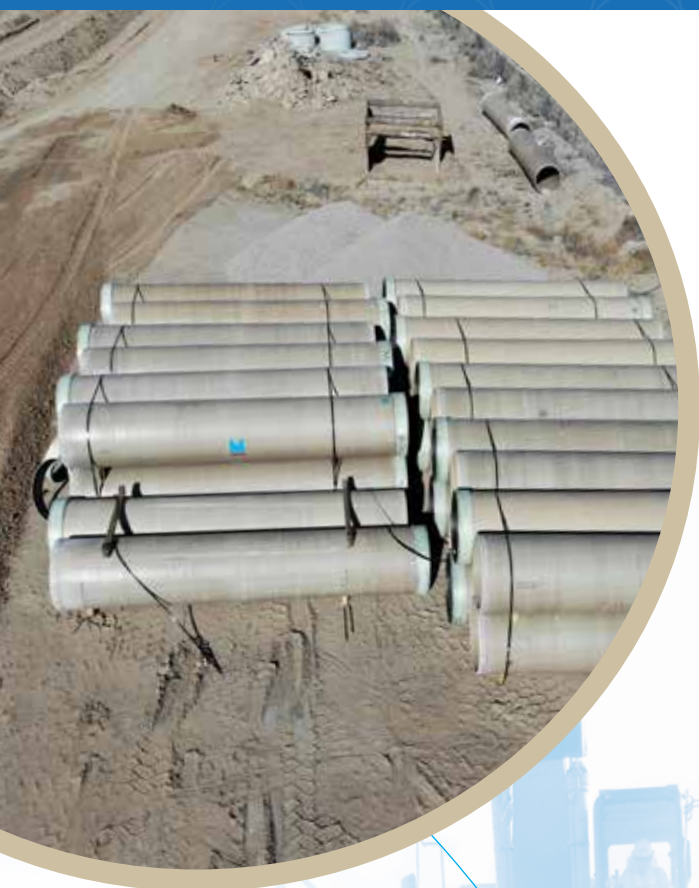
When selecting materials, AMAFCA chose Hobas centrifugally-cast, glass-fiber-reinforced, polymer mortar 42-inch and 36-inch pipes with tee bases and 30" flanged tops to serve as irrigation piping for agriculture.

When selecting materials, AMAFCA chose Hobas centrifugally-cast, glass-fiber-reinforced, polymer mortar 42-inch and 36-inch pipes with tee bases and 30” flanged tops to serve as irrigation piping for agriculture.

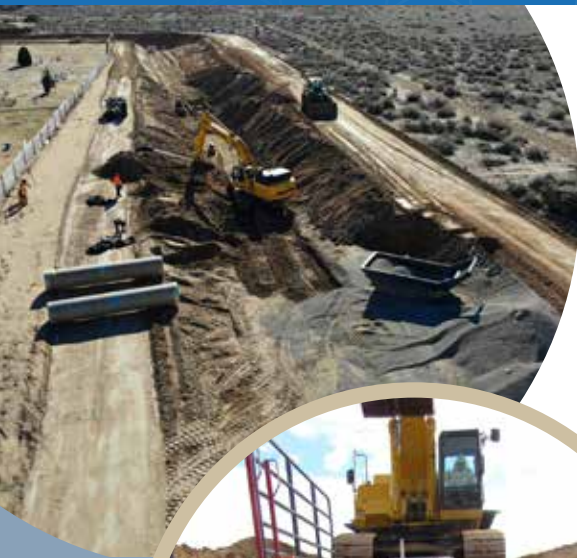
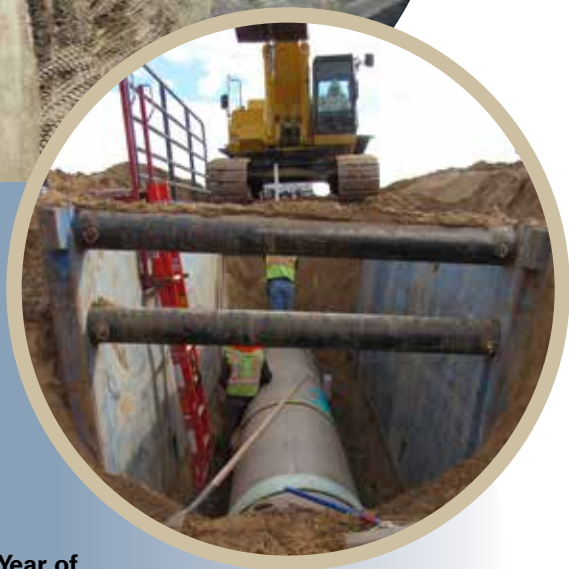
Year of construction
2019
Length
4,480 feet
Diameter
42 & 36-inch
Stiffness class
46 & 90 psi
Installation method
Direct bury
Application
Storm water
Client
AMAFCA
Installer
AUI Inc.

“Hobas fittings and flanges are specially fabricated,” Friedt said. “All of the fittings are fiberglass bends with an angle bend in 37-foot sections [using 20’ complete lengths of pipe]. For Phases III and IV, we ordered the Hobas fittings back in August to be sure they were delivered even before construction started.”
