Naches-Selah Irrigation District Upgrades System

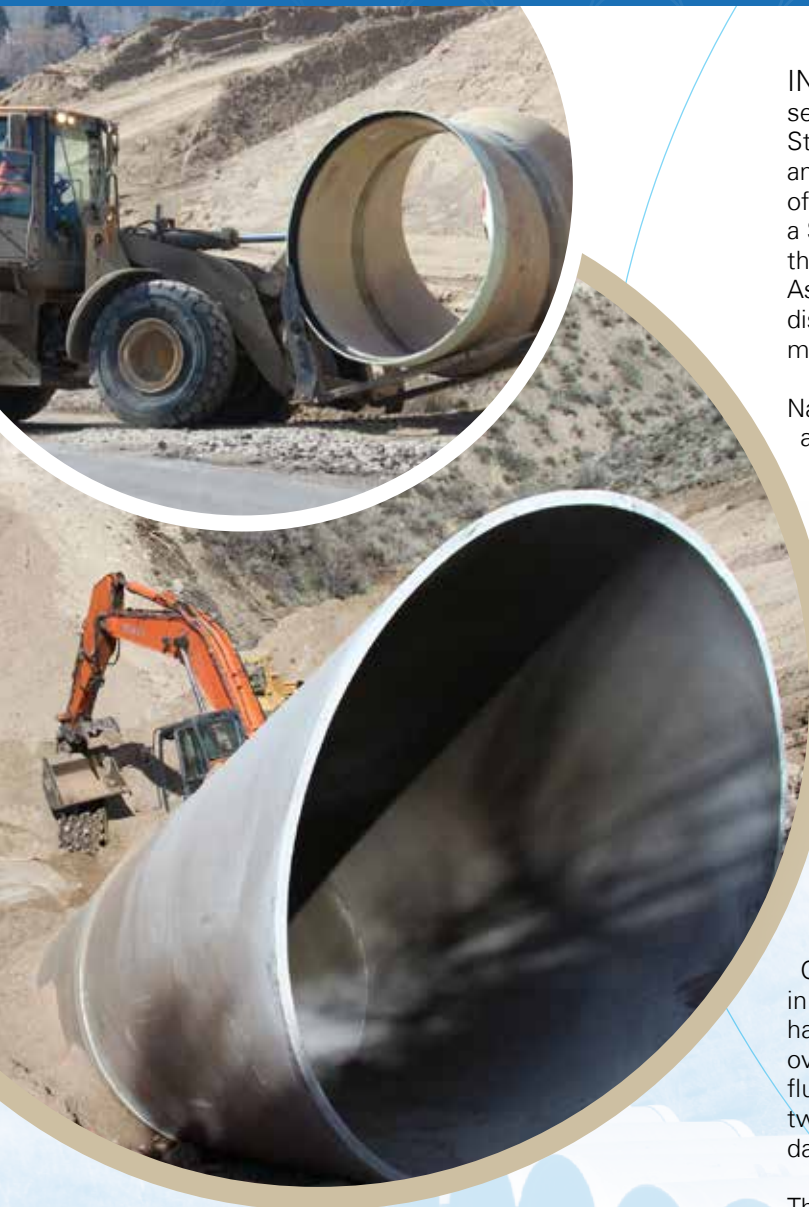
The existing wood stave flumes were replaced with 96-inch inverted siphons made of HOBAS Pipe.

Wood stave flume trestles were replaced with inverted siphons. The large inverted siphons are used to convey water being carried in canals or flumes across valleys for irrigation. With no pump, they are powered by the fall of the water as it flows down the pipe under the pull of gravity, and discharged at a level lower than the surface of where it originated.

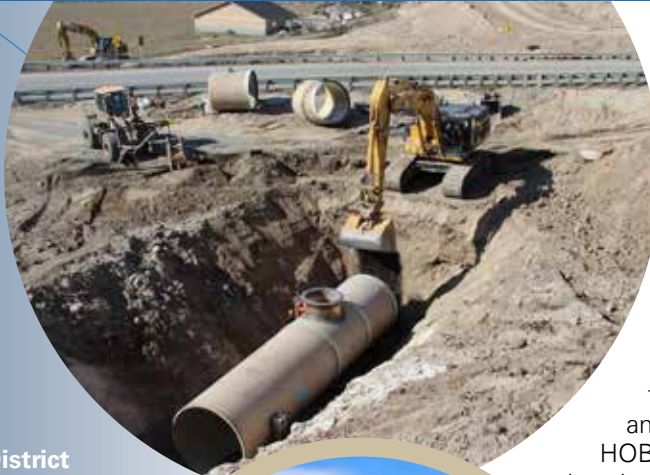
Custom fittings were manufactured of the same material as the CCFRPM pipe to meet the design requirements.

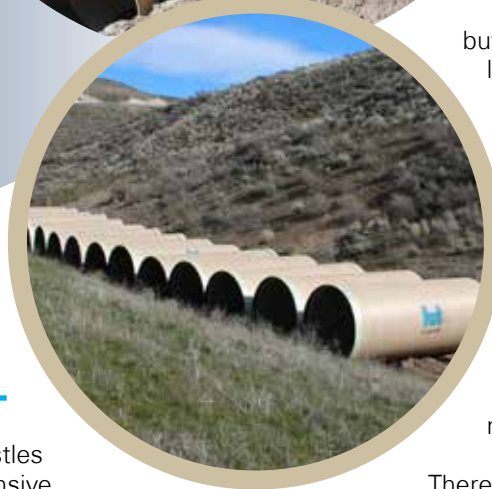
Ease of installation allowed Tapani, Inc. to meet the project schedule in time for the start of the 2015 watering season.
